AMMRC TR 78-51

# EXPERIMENTAL TESTING OF AN ACCORDION SHELL FOR AN EXPANDABLE SHELTER

December 1978

ARMY MATERIALS AND MECHANICS RESEARCH CENTER  
Watertown, Massachusetts 02172

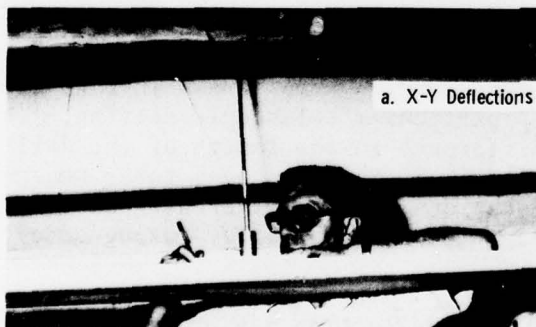
Figure 12. Roof deflection measurements being taken.

Figure 11 shows the sign convention used for deflection measurements and Figure 12 shows roof deflection measurements being taken. The appropriate telescopic device is placed on a graph paper which is taped to the upper surface of the reference plank below a roof deflection location. The device is moved and adjusted until the pointed end of the drill rod is just touching a marked deflection point. The four corners of the base plate of the device are then traced on

the graph paper with a pen or pencil as shown in Figure 12a. The device is then removed. By using the traced corner markings as a guide, the center is marked with an "X" which represents the point on the graph paper directly below the roof deflection point. Repeating this procedure after each loading increment results in a series of X's on the graph paper which track the horizontal of X-Y (see Figure 11) motion of the deflection point. The Z deflection measurements are obtained by measuring the distance between the deflection point and the appropriate X on the graph paper (see Figure 12b).

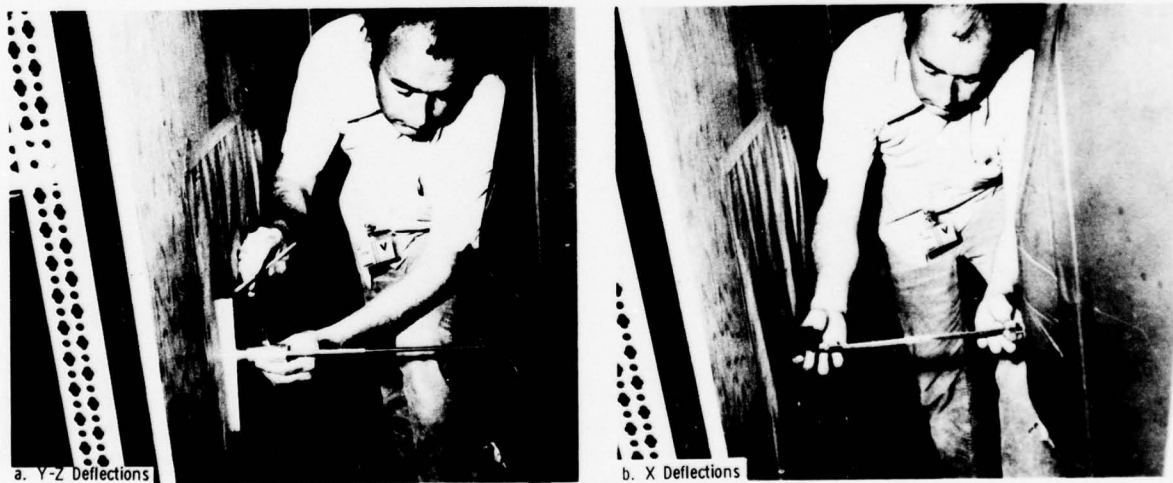
Figure 14. Side wall deflection measurements being taken.

A wooden reference "wall," shown in Figure 13, was constructed for taking side wall deflection measurements. Figures 14a and 14b show side wall deflection measurements being taken using the shortest telescopic device. In taking these measurements, the Y and Z deflections (see Figure 11) were tracked on the graph paper and the X deflection was read from a scale.
